Railgun Materials Science

R.A. Meger
Plasma Physics Division

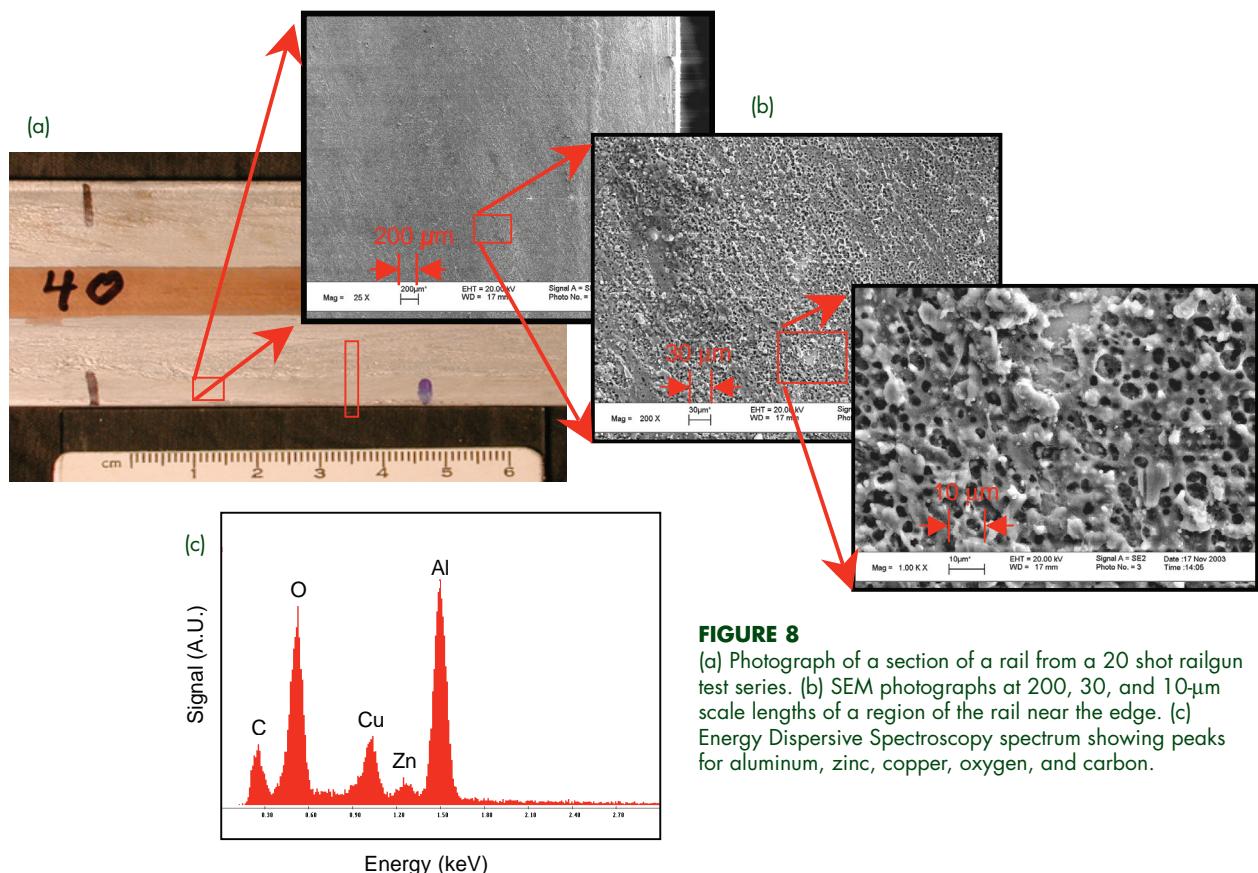
Figure 8(a) shows the rail top surface. The gray colored material is aluminum that has melted off the sliding armature. The three boxes (Fig. 8(b)) show increasing magnification scanning electron microscope (SEM) photographs of the aluminum deposit at one edge. The images at 200-, 30-, and 10- μm scales show the top surface of a thin aluminum layer on the copper rail. Figure 8(c) shows the spectrum generated by Energy Dispersive Spectroscopy (EDS) from near one of the 5- μm sized voids in the aluminum. EDS allows one to determine the atomic constituents near the surface

of the material. The spectrum shows a large peak where aluminum is expected. Likewise there are peaks from zinc, copper, oxygen, and carbon.

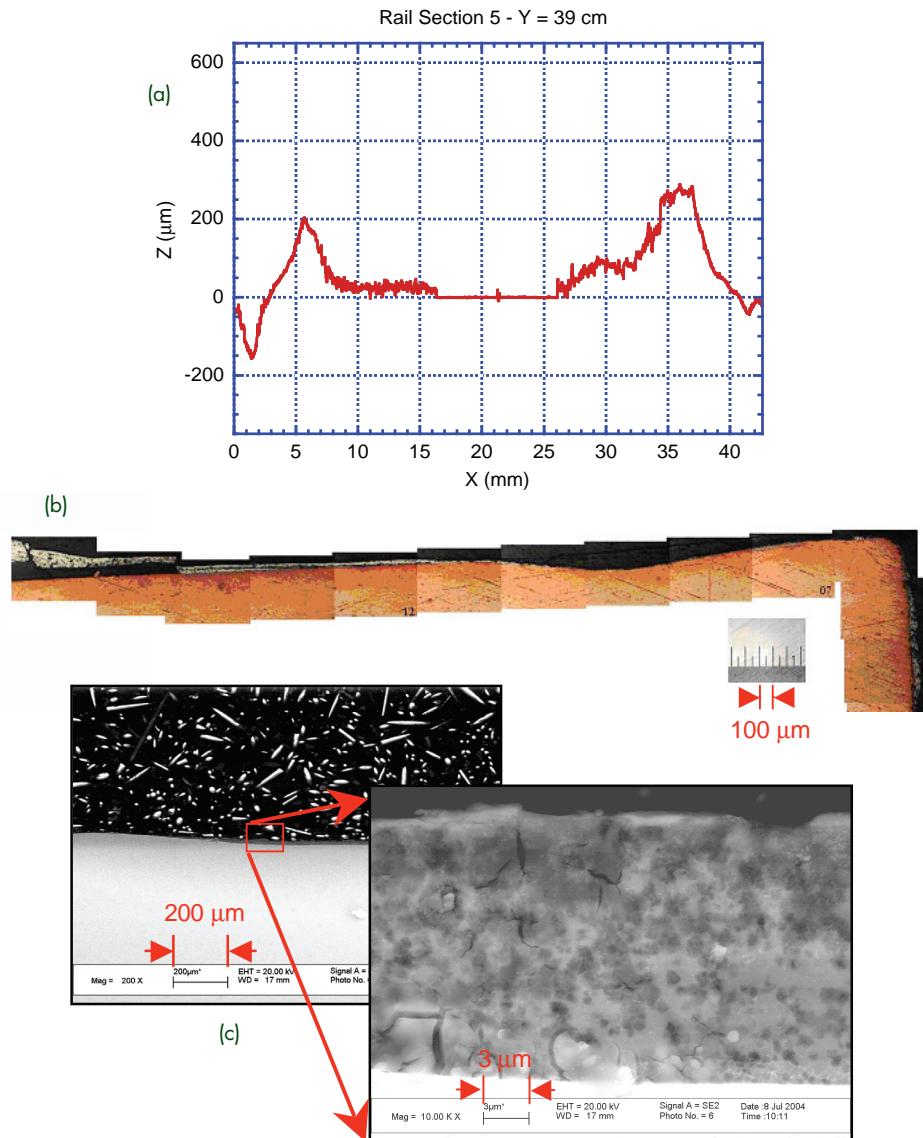
FIGURE 9

Figure 9(a) shows a scan from a stylus profilometer of the surface at the 39-cm location. The scan shows that the surface has been eroded by approximately 150 μm near the edge of the rail and to a lesser depth on the other side. In between there appears to be a deposit, found to be a mixture of aluminum and copper, of 200 to 250- μm thickness. Figure 9(b) shows a high-resolution image of the edge of the rail near the 40-cm location approximately where the rectangle in Fig. 8(a) is located. The erosion of the copper near the edge is clearly visible. Figure 9(c) shows SEMs of the ~15 to 20 μm thick edge inside of the groove region. There is evidence of copper dendrites forming near the interface and copper-aluminum crystal formation within the deposit. In the thick deposit region, layers of aluminum were clearly visible in the SEM photographs, showing that the thickness grew from shot to shot. In addition, there have been a variety of X-ray diffraction, X-ray fluorescence, surface stress, material hardness, and other diagnostics applied to the surfaces and cross sections of these rails. From the different diagnostics, a picture of the rail-armature interface under high-power conditions during the acceleration process is being developed.

(a) A scan from a stylus profilometer at the 39 cm location on the rail section shown in Fig. 8(a).
 (b) A montage of high-resolution photographs of the cross section near the edge of rail segment in Fig. 8(a). (c) SEM photographs of the deposit on the copper rail in the vicinity of the groove on the edge of the rail.
